UNDERWATER BRIDGE INSPECTION REPORT

STRUCTURE NO. 90907

SOUTH BRANCH OF THE BUFFALO RIVER

DISTRICT 4 - CLAY COUNTY

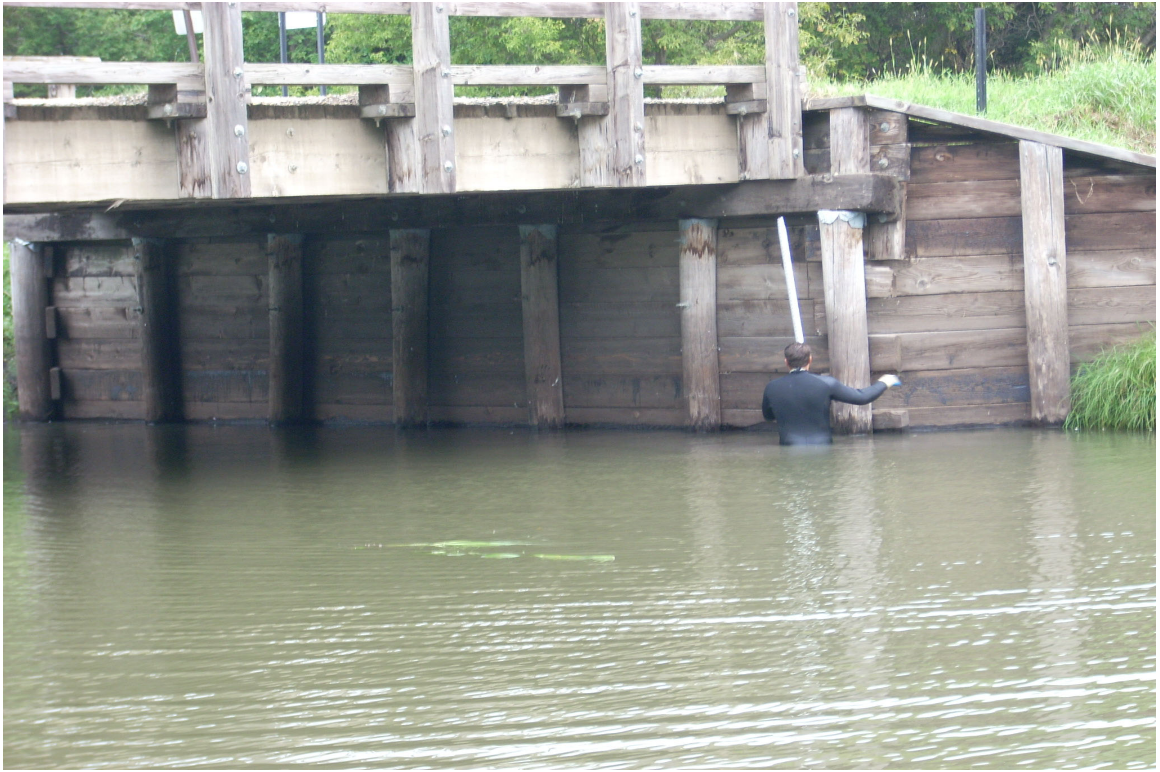
Photograph 1. View of East Abutment, Looking Northeast.

- (E) The north end of the East Abutment pile cap was decayed with up to 1 foot of penetration. (This is beginning to affect the bearing capacity on the downstream pile.)

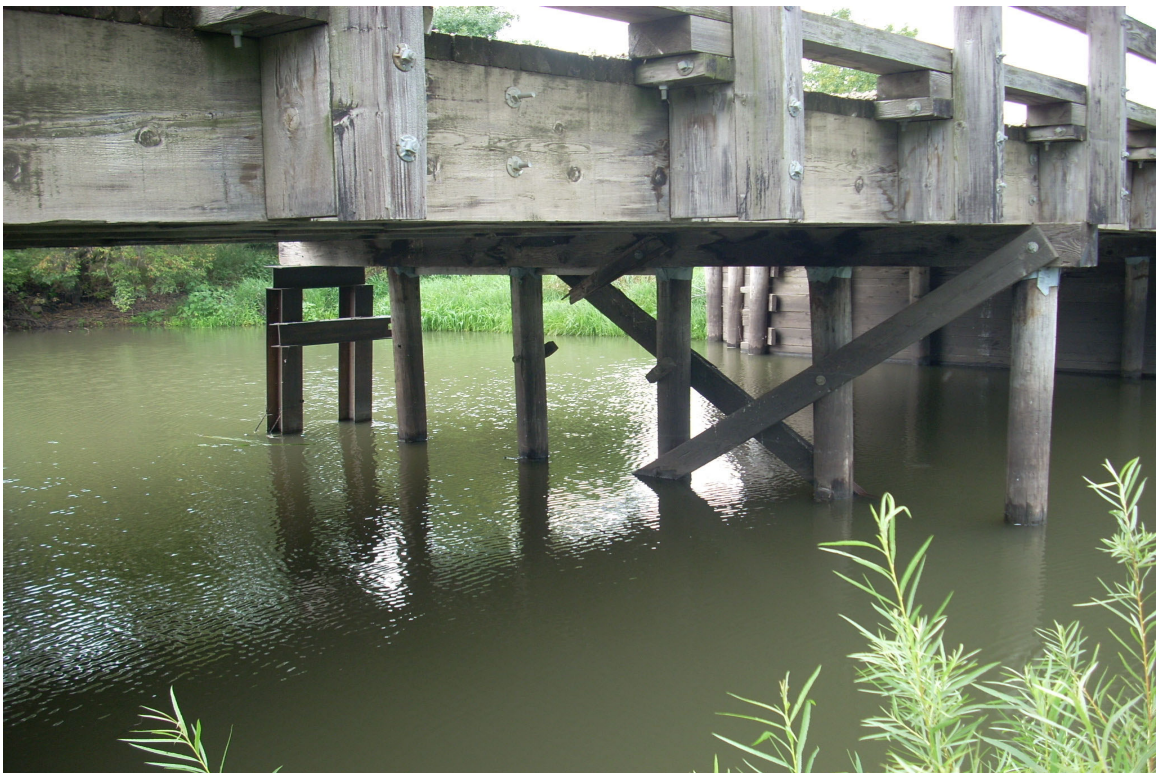
Photograph 2. View of Pier 1, Looking Southwest.

- (B) The second timber pile from the downstream end of Pier 1 was hollow from 2 feet below to 2 feet above the waterline with 20 percent section loss.

- (C) The downstream timber pile of Pier 1 was hollow from 3 feet below to 3 feet above the waterline with an estimated 50 percent section loss. Within the same area of the pile, the outer shell was soft with up to 2 inches of awl penetration.

- (F) The diagonal timber bracing was broken / missing on the east and west sides of Pier 1 on the three upstream timber piles.
- (G) The two H-piles with a horizontal steel brace, which replaced the original upstream timber pile, exhibited light surface corrosion with minor pitting up to 1/32 inch deep.

- (A) Replace the missing lateral bracing on Pier 1 to re-establish the lateral stability of the structure.
- (B) Monitor the timber piles that exhibited section loss during future inspections. A structural review should also be made to assess the need for replacement and/or helper piles at this time.
- (C) Reinspect the submerged substructure units at the normal maximum recommended (NBIS) interval of five (5) years.

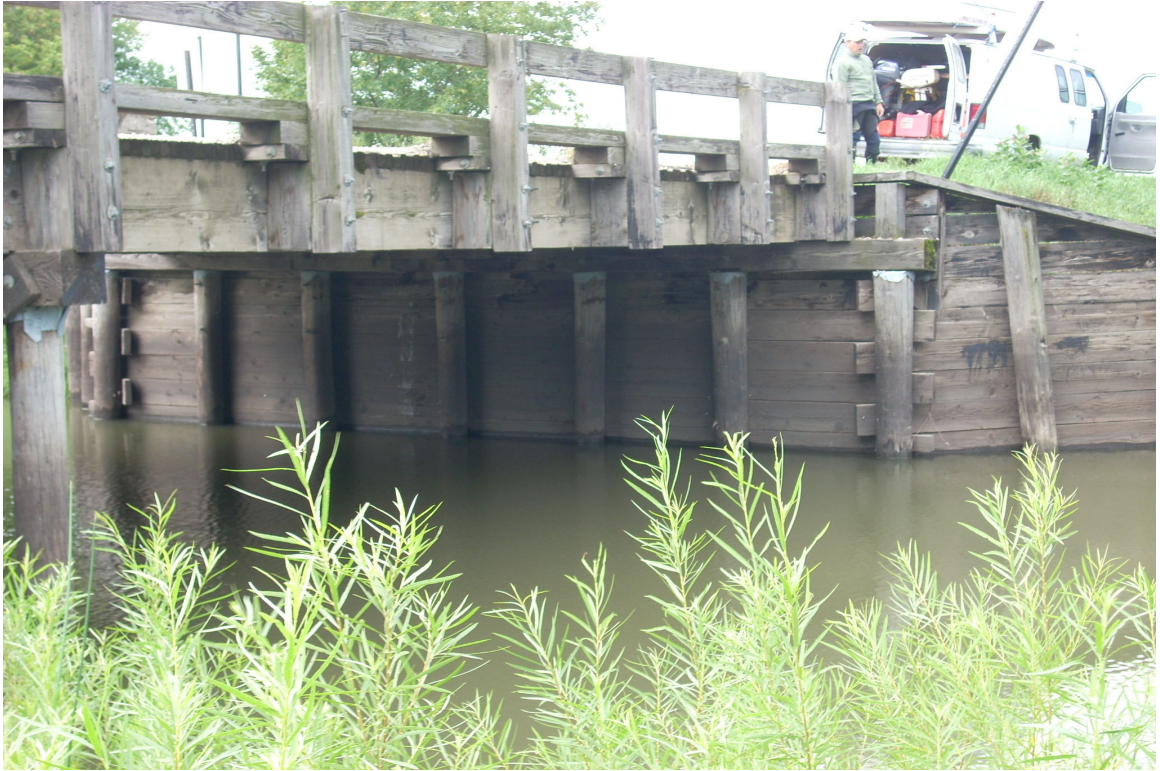
Photograph 3. View of West Abutment, Looking Southwest.

- (D) The second timber pile from the downstream end of the West Abutment was hollow from the waterline to 3 feet below with an estimated 50 percent section loss.

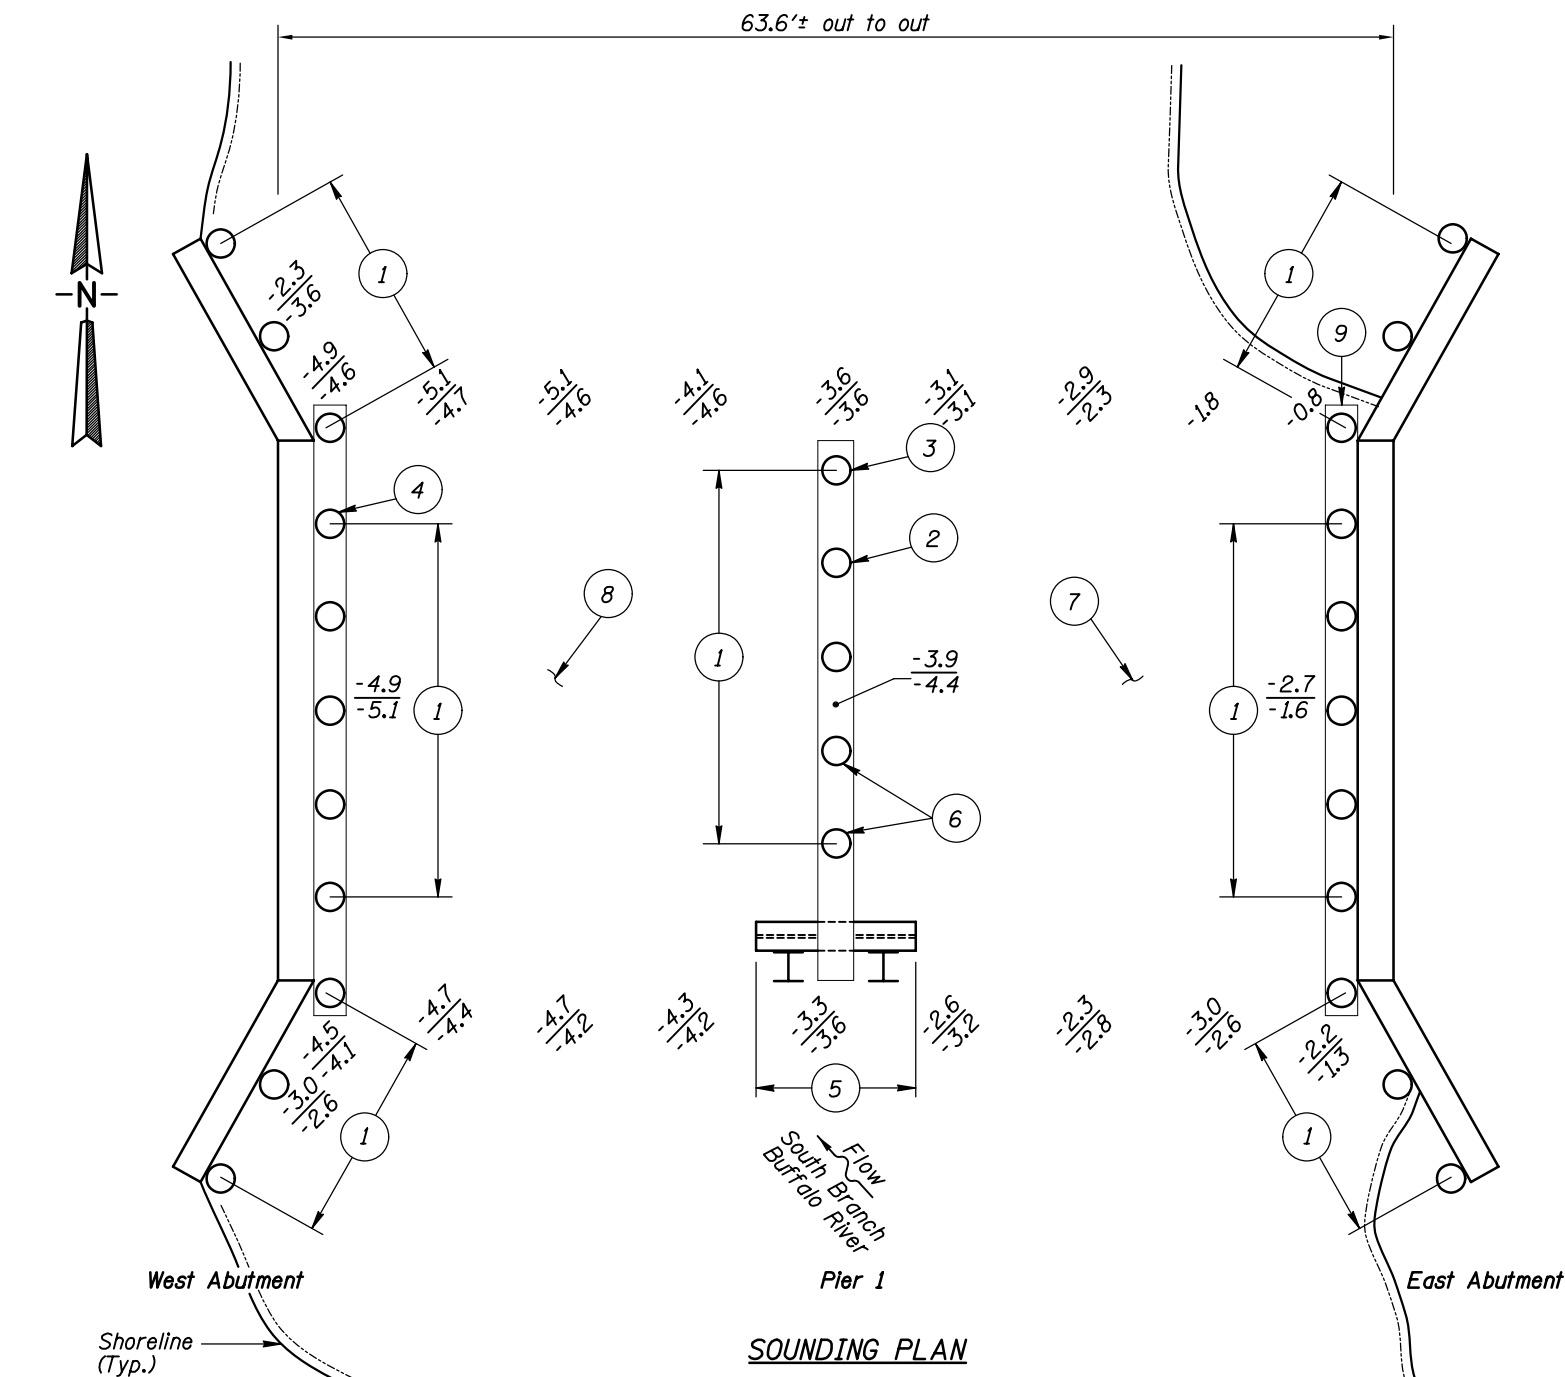
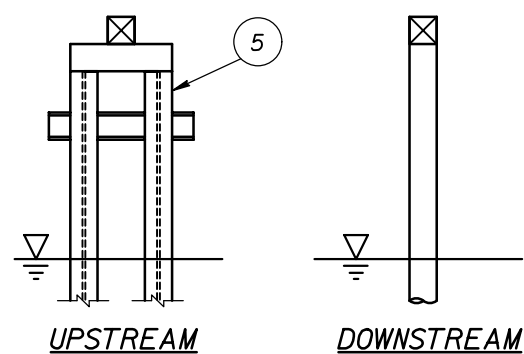
INSPECTION AND SOUNDING PLAN

- 1 The timber piles, caps, bracing, and abutment sheeting exhibited random minor checks up to an 1/2 of an inch wide and typical awl penetration between 1/2 and 3/4 of an inch into the timber.

- 2 The second timber pile from the downstream end of Pier 1 was hollow from 2 feet below to 2 feet above the waterline with 20 percent section loss.
- 3 The downstream timber pile of Pier 1 was hollow from 3 feet below to 3 feet above the waterline with 50 percent section loss. In the same area of the pile, the outer shell was soft with up to 2 inches of awl penetration.

- 4 The second timber pile from downstream end on the west abutment was hollow from the waterline to 3 feet below with 50 percent section loss.
- 5 The two steel H-piles with a horizontal steel brace, which replaced the original upstream timber pile, exhibited light surface corrosion with minor pitting up to 1/32 of an inch deep.

- 6 The diagonal timber bracing was broken/missing on the east and west sides of Pier 1 on the three upstream timber piles.
- 7 The channel bottom between Pier 1 and east abutment consisted of soft silt with up to 2 feet of probe rod penetration.

- 8 The channel bottom consisted of silty clay with 1 foot of probe rod penetration.
- 9 The North end of the East Abutment pile cap was decayed with up to 1 foot of penetration. (This is beginning to affect the bearing capacity on the downstream pile)
